CHAPTER I

INTRODUCTION

1.1 Background

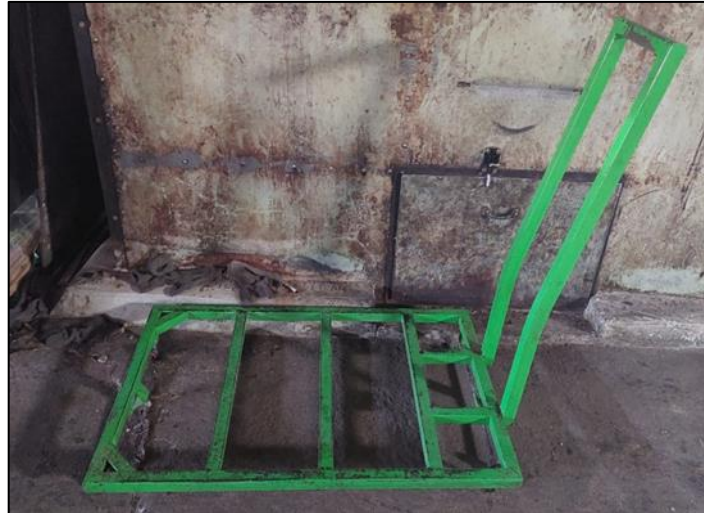
Figure 1.1 Recent Trolley Used by Yanna Bakery

This trolley was built at the workshop in mid-May 2021 for IDR 500,000 to fulfill an inspection permit where the baking sheet is not permitted to be placed on the floor. When moving the pan from the dough forming point to the loaf steamer, the trolley travels approximately 10 meters. The trolley is used not only to transport the dough to the loaf steamer, but also to transport the baking sheet containing the baked dough from the oven to the bread cooler. **Figure 1.1** shows the design of the trolley used by Yanna Bakery.

Trolleys used in industry should be ergonomically designed to accommodate humans in the environment (Santoso, 2013). The handle of the trolley used by the Yanna Bakery has been designed to meet the needs of the operator, with the handle being pushed with both hands of the operator. The trolley's base is only 7.5 cm from the floor, indicating that the location of the base is less ergonomic, where a baking sheet containing bread can be considered unhygienic if exposed to dust or something else with the height of the existing base. The distance from the base to the ground surface is displayed in **Figure 1.2** (a). The trolley's wheels are made of iron, which, if pushed through the cement-based floor surface, can cause

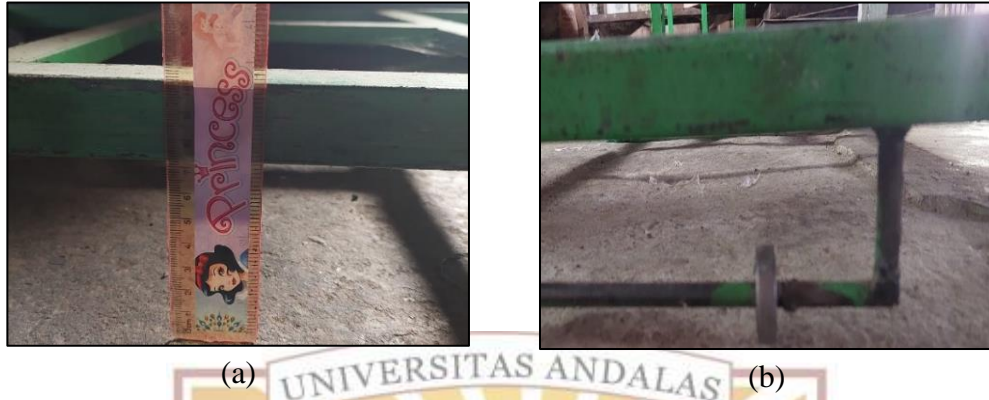
Figure 1.2 (a) Distance from the trolley's base to the floor surface; (b) Trolley
Wheels

deterioration and cause the floor surface to become more uneven over time. The trolley's wheels are displayed in **Figure 1.2** (b).

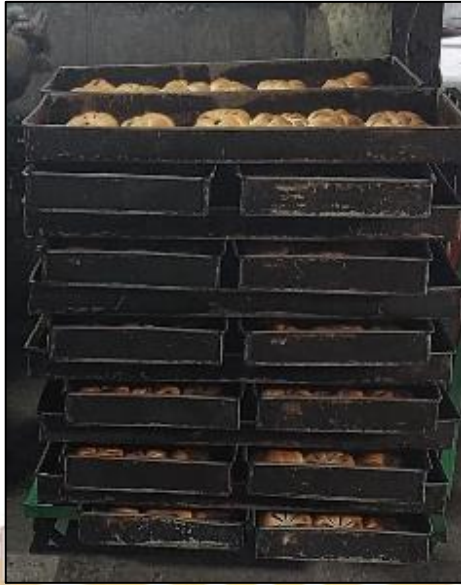
Figure 1.3 Trolley with a Pile of Baking Pans

Humans will suffer a variety of negative effects if the product design is less ergonomic. These negative effects on humans can occur both in the short and long term. Working in non-ergonomic conditions can result in a variety of worker complaints, such as pain, fatigue, and even accidents (Santoso, 2013). The following are some of the problems highlighted by trolley operators. The first is that the operator is subjected to a heavy load while pushing the trolley, necessitating the use of more power because the wheels are still in the form of bearings on the cement floor surface. The stacked baking sheet in **Figure 1.3** may also fall if there is an incident, whether caused by an uneven floor surface or something else. This is due to the trolley's lack of a stopper in dealing with the incident.

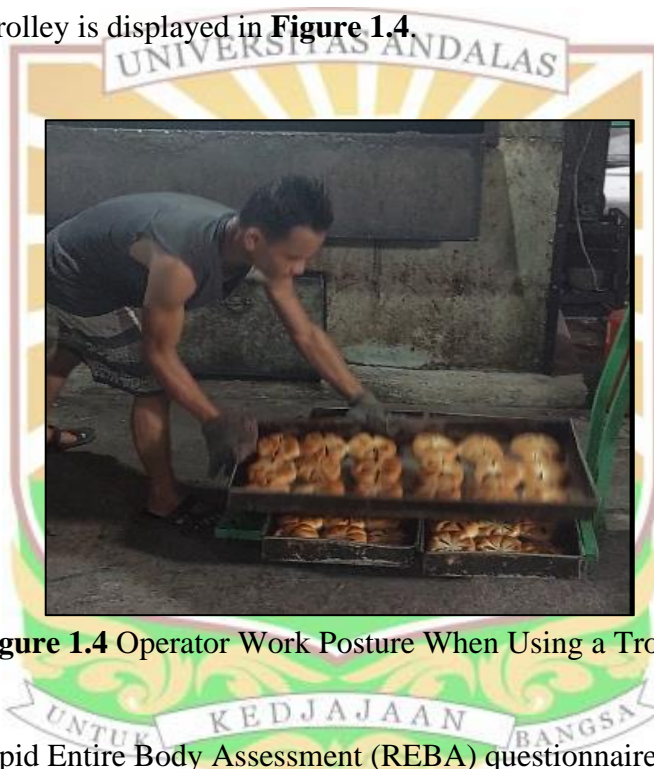
Figure 1.4 Operator Work Posture When Using a Trolley

The activity of lifting the baking sheet containing the baked dough onto the trolley shows several risk factors with the cumulative results of each risk on the back, forearms, neck/shoulders, and wrists based on one of the ManTRA scores shown in **Table 1.1**. Because of the score of exertion risk is worth 5, the sum of the exertion and awkwardness scores is worth 9 (8 or more), and the cumulative risk score is worth 15 (except neck/shoulder), further action may be indicated. Other activities' ManTRA scores can be seen in the **Appendix**. Furthermore, this is caused by the operator, who repeatedly performs the activity of placing the pan on the trolley with less ergonomic work postures. The working posture of the operator when using a trolley is displayed in **Figure 1.4**.
